## ADVANCED COMPOSITE WING COVER-TO-SUBSTRUCTURE ATTACHMENT (CTSA) DEVELOPMENT PROGRAM

Grumman Aerospace Corporation  
Bethpage, New York 11714

TECHNICAL REPORT AFFDL-TR-78-190

Final Report for Period July 1977 - November 1978

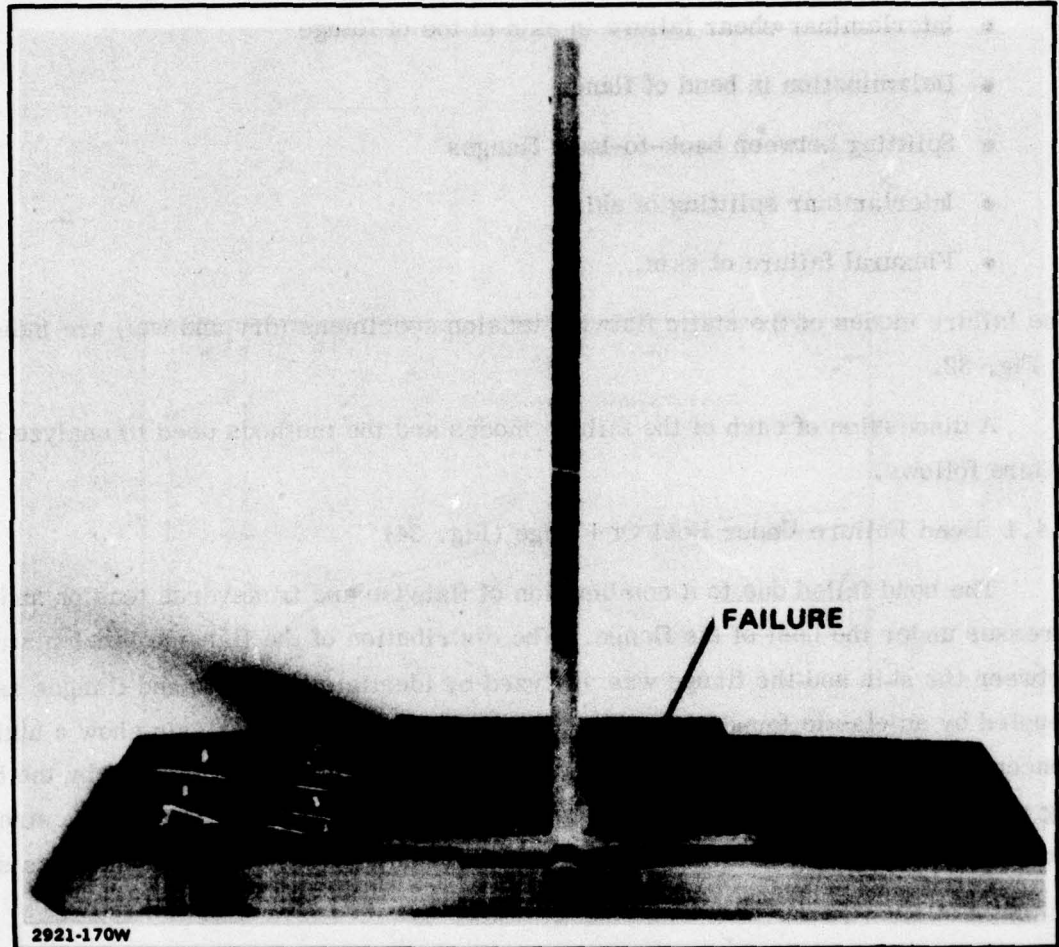
Fig. 34 Bond Failure Under Heel of Flange

#### 3.4.1 Bond Failure Under Heel Of Flange (Fig. 34)

The bond failed due to a combination of flatwise and transverse tension and shear stresses under the heel of the flange. The distribution of the flatwise tension stress between the skin and the flange was analyzed by idealizing the skin and flanges as beams coupled by an elastic foundation (Ref. 3). The results of the analysis show a high stress concentration immediately under the heel of the flange, caused primarily by the bending of the skin so as to impose zero slope at the centerline of the joint. The stress concentration can be reduced by increasing the bending stiffness of the skin, as shown in Fig. 35.

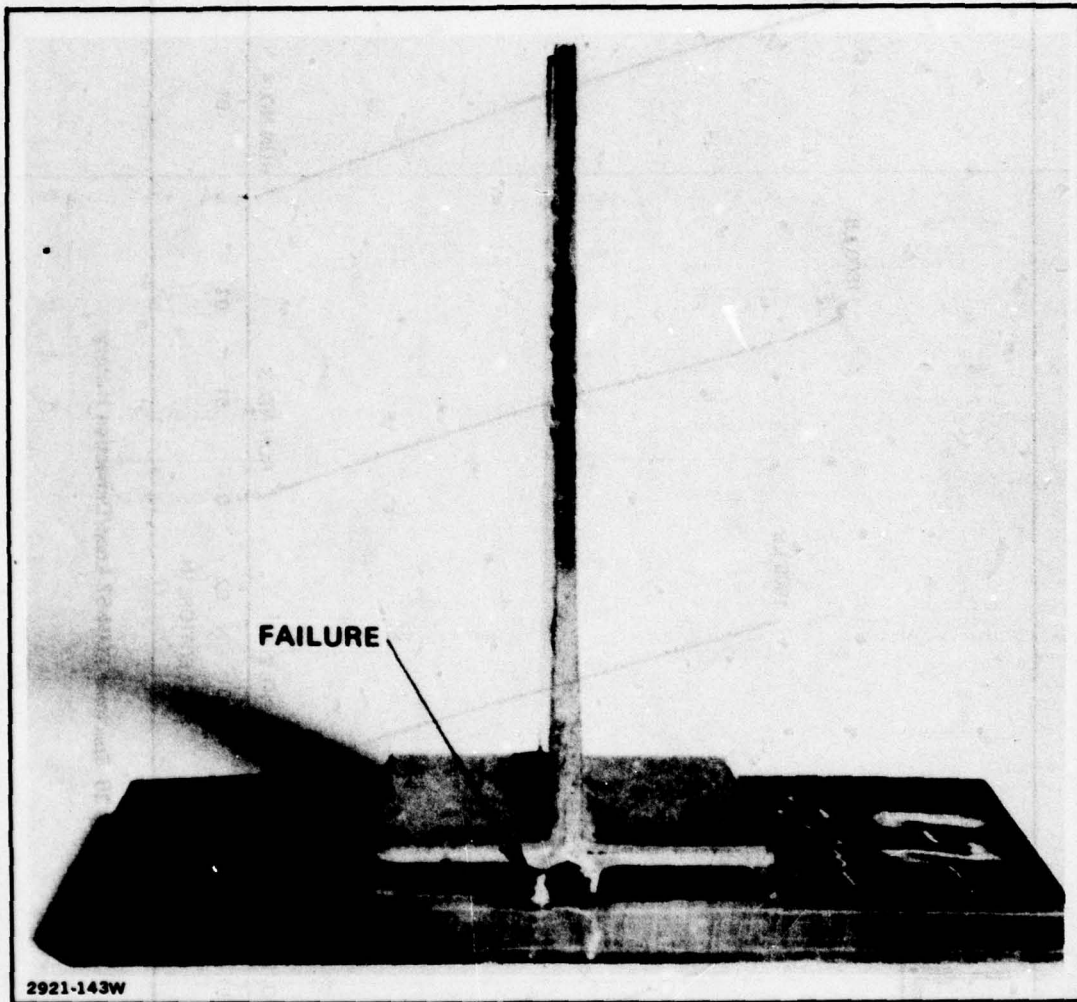
**Fig. 37 Failure of Stitch**

#### 3.4.2 Failure of Stitch (Fig. 37)

The stitch failed in tension, and the failure can be predicted on the basis of a simple "heel and toe" action of the flange with tension in the stitch near the heel and bearing pressure over a small area at the toe of the flange. The matrix can be neglected in this analysis because the matrix failed before the stitch as a result of the combination of high flatwise tension and shear stress at the heel. In fact, the stitch acts as a form of crack stopper to the spread of the bond failure and the joint carries further load after the bond failure.

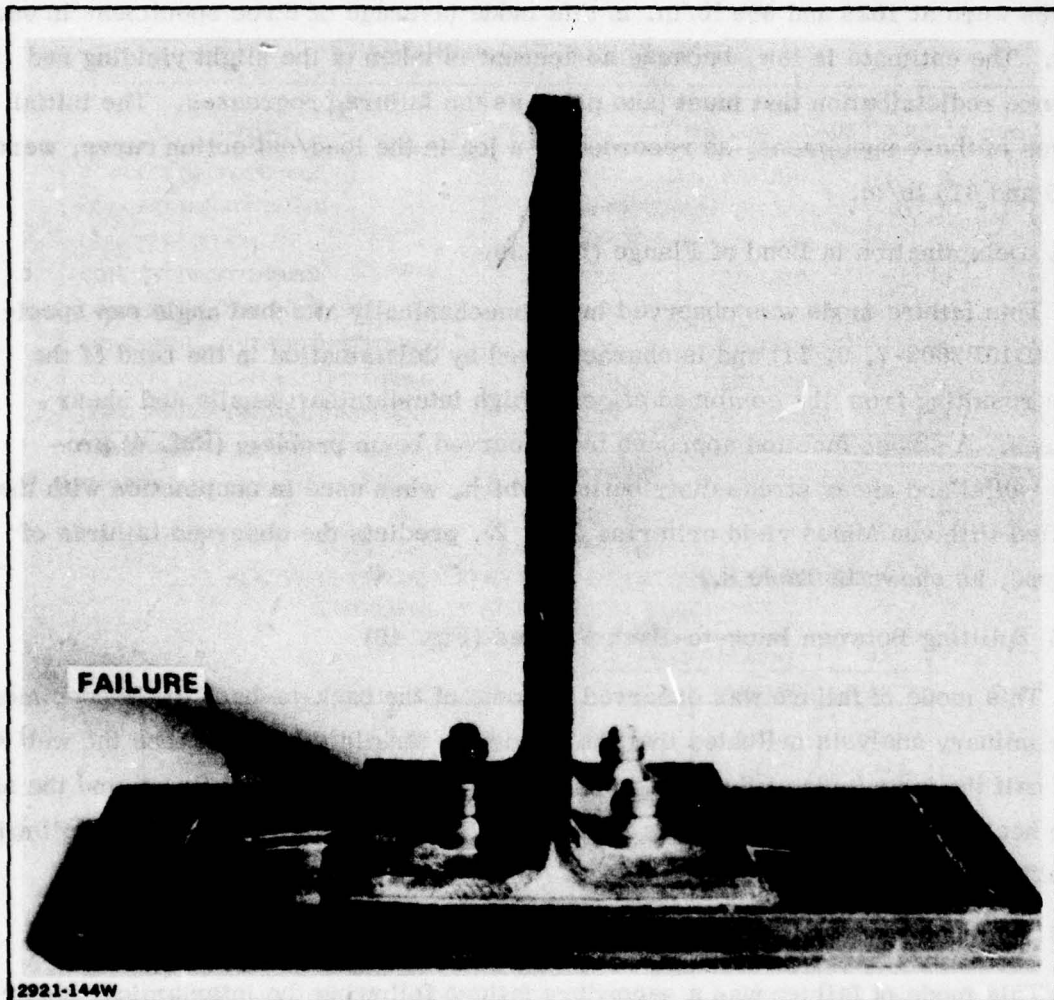
**Fig. 38 Interlaminar Shear Failure in Skin at Toe of Flange**

#### 3.4.3 Interlaminar Shear Failure Of Skin (Fig. 38)

This failure was not a failure of the joint, but occurred in the skin close to the toe of the flange where the overall section changes abruptly on the test specimens. This abrupt change could be eliminated in future designs by tapering the flange from heel to toe.

Analysis of the specimens that failed in this way shows evidence of a nonuniform load introduction. Anticlastic curvature of the skin, coupled with the bending flexibility of the roller, caused the load to be concentrated at the outer edges of the specimen. A simple analysis shows the roller to be in contact with the skin surface over

only 0.40 in. at each edge, and this was confirmed by the appearance of indentation marks, typically about 1/2 in. long, on the surface of the specimens.

Failure analysis based on the maximum interlaminar shear stresses under the peak bearing location gives an estimated failure load of 603 lb/in. for the joint. Test failures were at 1028 and 869 lb/in. in this mode (average of three specimens in each case). The estimate is low, because no account is taken of the slight yielding and pressure redistribution that must take place as the failure progresses. The initial failures of these specimens, as recorded by a jog in the load/deflection curve, were at 785 and 615 lb/in.

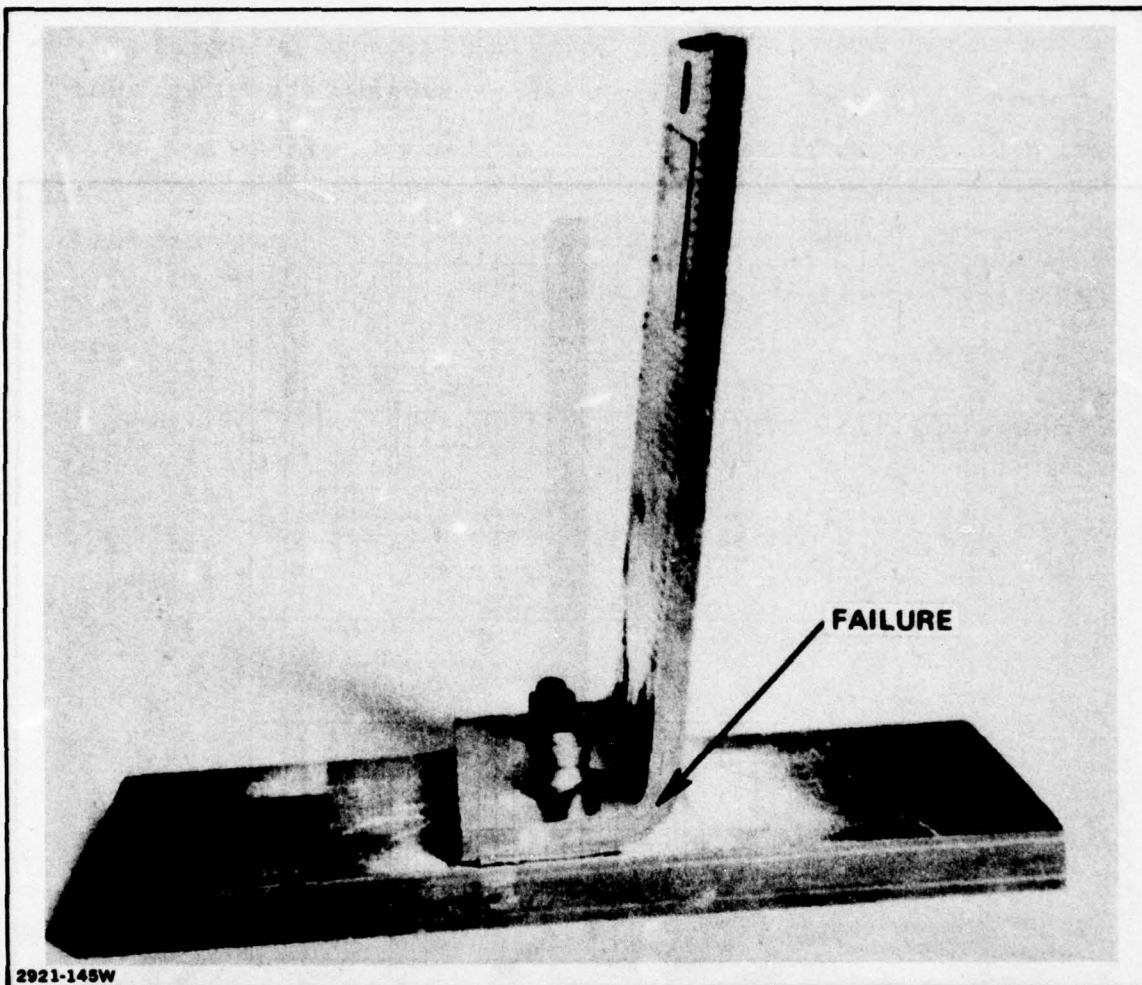
Fig. 39 Delamination in Bend of Flange

This failure mode was observed in the mechanically attached angle cap specimens (D10B2003-7, 9, 11) and is characterized by delamination in the bend of the flange resulting from the combined effect of high interlaminar tensile and shear stresses. A stress function approach to the curved beam problem (Ref. 4) produces radial and shear stress distributions which, when used in conjunction with the modified Hill-von Mises yield criterion (Ref. 2), predicts the observed failures of this type, as shown in Table 8.

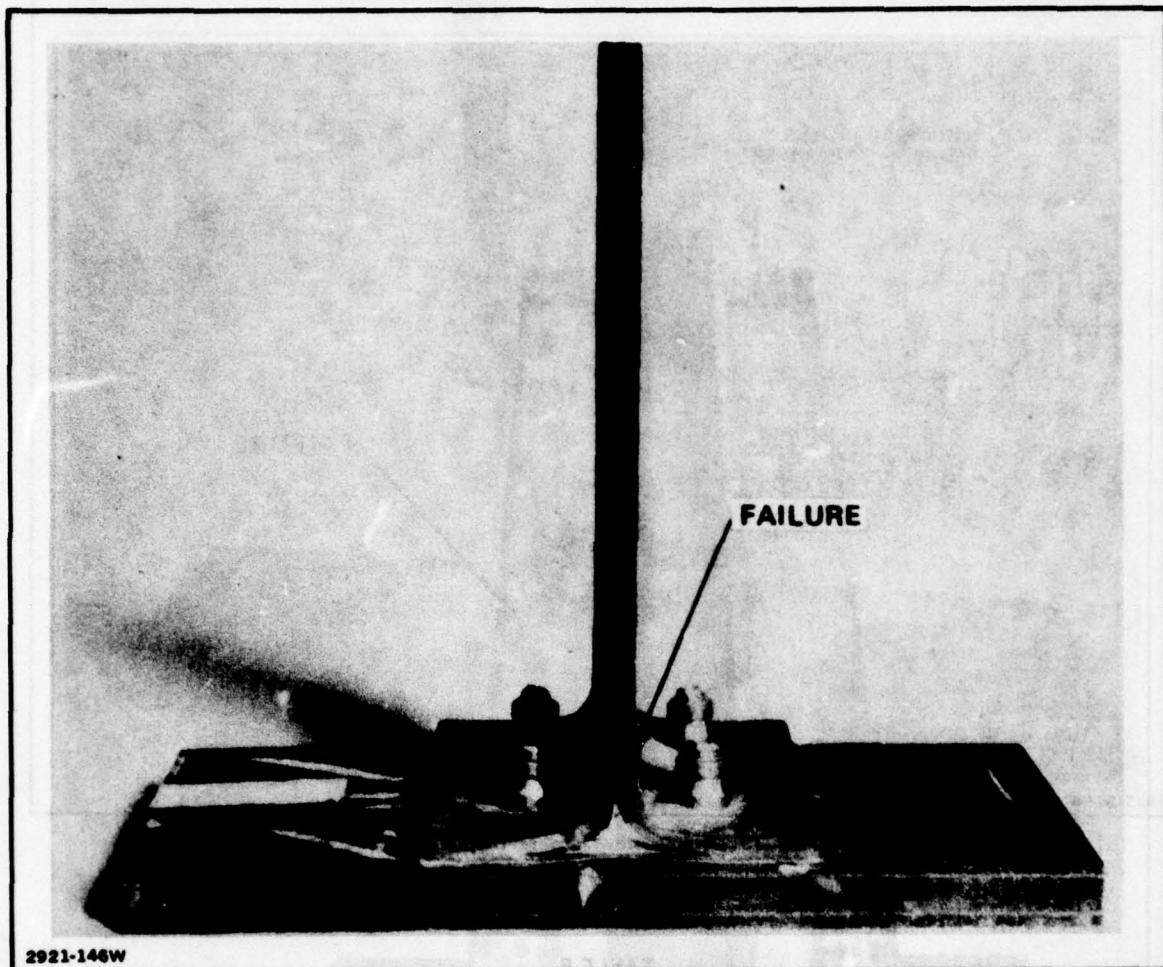
**Fig. 40 Splitting Between Back-To-Back Flanges**

This mode of failure was a secondary failure following the interlaminar shear failure of the skin. It appears that the interlaminar shear crack propagated diagonally through the laminate until it reached the 90° (chordwise) layers, at which point the crack propagated in the chordwise direction along the 90° layers. Analogous behavior is observed in steel reinforced concrete beams where diagonal tension cracks often result in splitting of the concrete along the tension reinforcement.

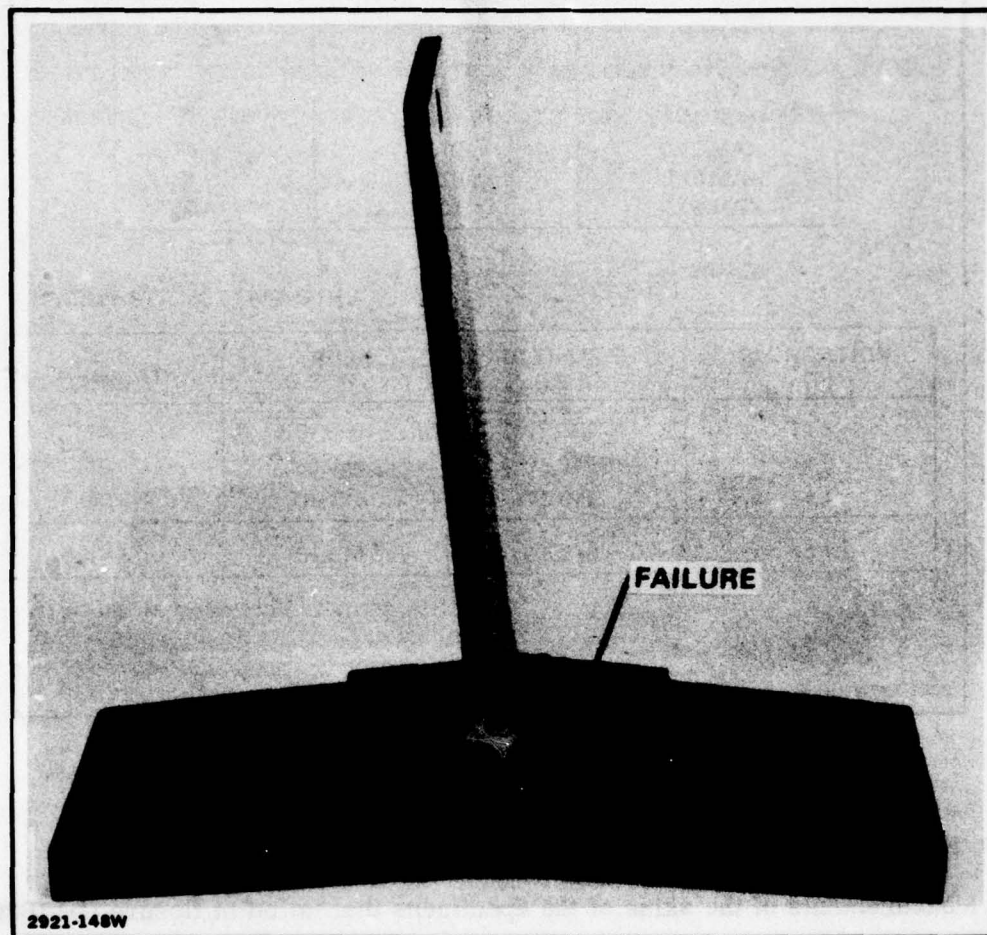
Fig. 42 Flexural Failure of Skin

#### **3.4.7 Flexural Failure of the Skin (Fig. 42)**

Measurements of the skins of the specimens that failed in flexure (D10B2005-43-3 and D10B2007-19-3) indicated markedly reduced per ply thicknesses resulting in bending stiffnesses which were significantly lower than those calculated using nominal layer thicknesses (41.7% and 16.8% reductions respectively). The results of tensile tests on stitched coupons indicate that the strength reduction caused by the stitch is equivalent to that caused by a 1/16 inch diameter open hole. This fact, used in conjunction with the actual bending stiffnesses and our notched laminate strength prediction method (Ref. 5), indicate the susceptibility of these specimens to flexural failure at -67° F as indicated in Table 9.

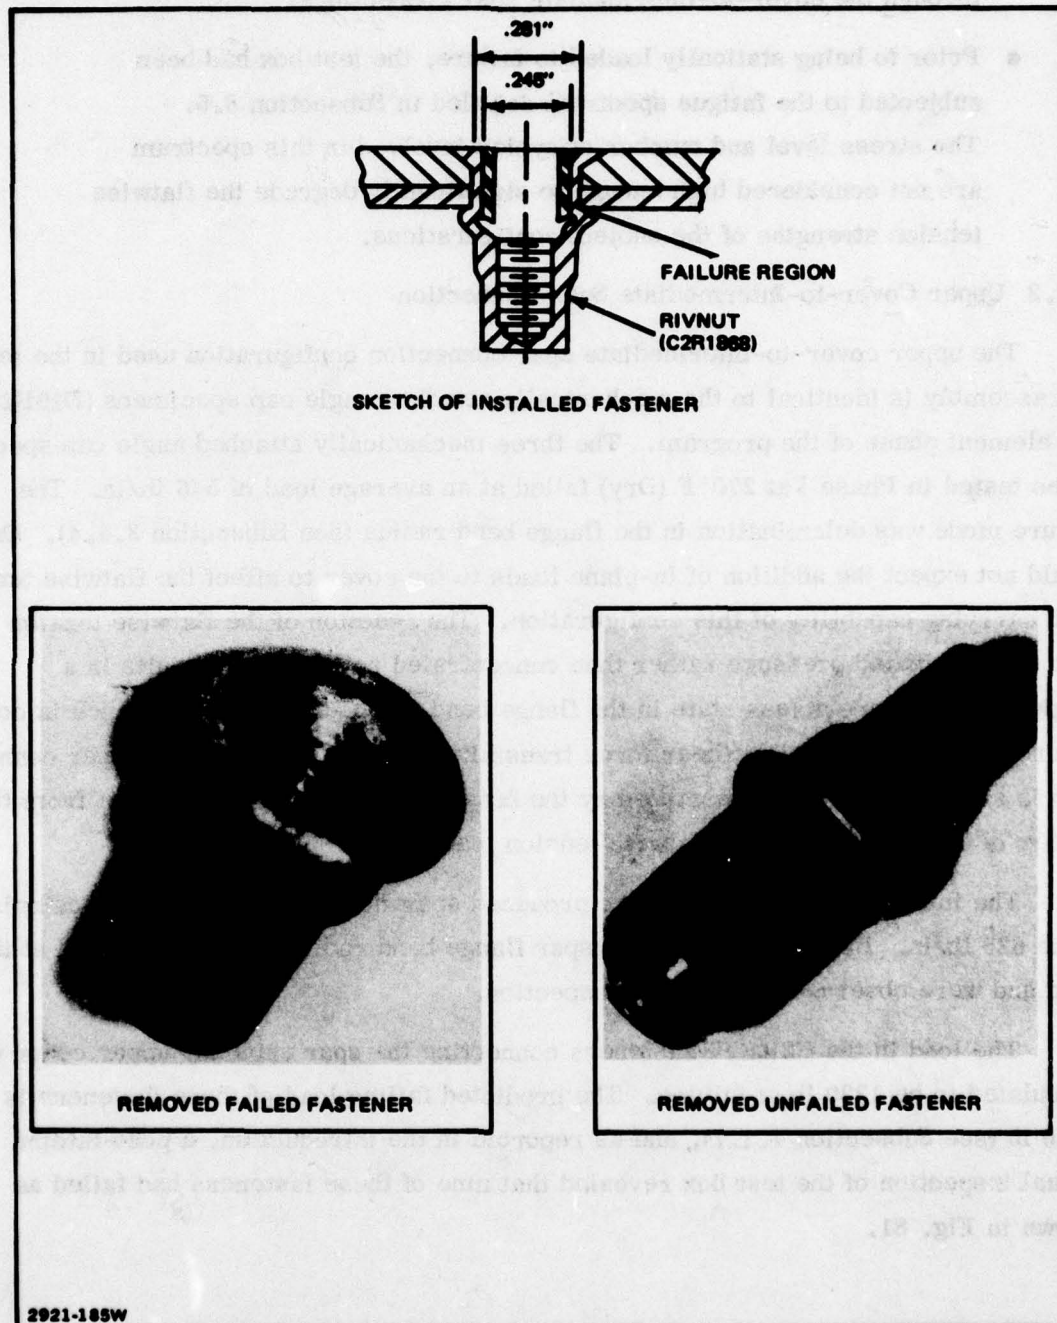
**Fig. 81 Failed Fasteners**

The load in the C2R1868 fasteners connecting the spar caps and upper cover was calculated to be 1330 lb at failure. The predicted failing load of these fasteners is 1190 lb (see Subsection 4.1.7), and as reported in the introduction, a post-failure visual inspection of the test box revealed that nine of these fasteners had failed as shown in Fig. 81.
